**Re: Poverty Bay Road Culvert Replacement**

As requested by the Township of Magnetawan, the Greer Galloway Group has completed an as-built survey of the Poverty Bay Road Culvert replacement project. This letter is in response to homeowners concerns regarding the culvert inverts, potential flow rates through the new culvert, and design parameters contained in the Canadian Highway Bridge Design Code (CHBDC).

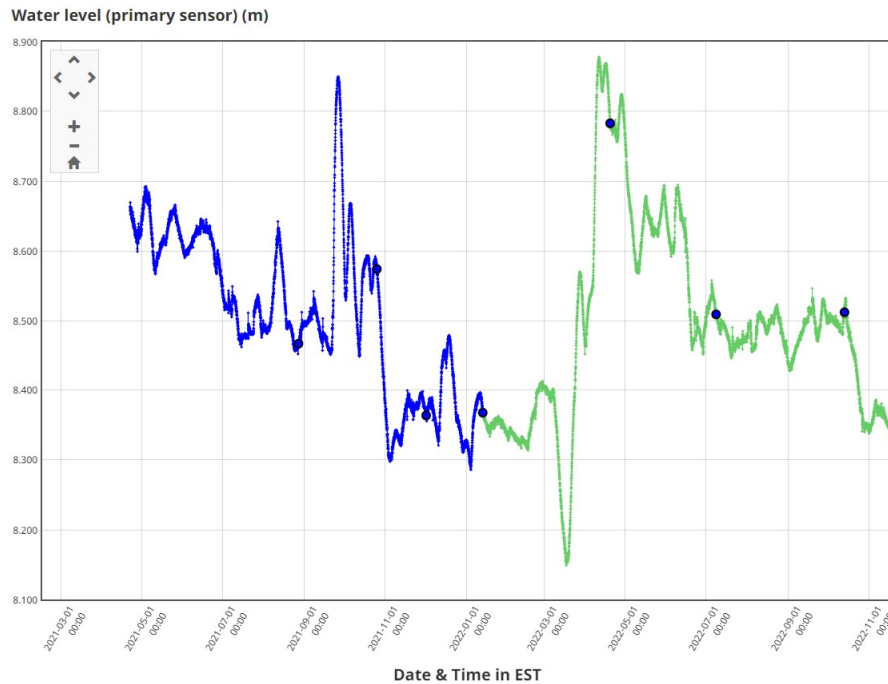
The Government of Canada maintains a real-time hydrometric data logger at Ahmic Harbor (02EA019- AHMIC LAKE) on Ahmic Lake. Below is a graph detailing the changes in water elevations from 2021-03-01 to 2022-11-01 (Blue is 2021, Green 2022). Of particular relevance for this letter is the change in water elevation from 2022-04-11 to 2022-11-17. During this time period, the water elevation dropped in Ahmic Lake by 535 mm. The downstream river level changes seasonally and yearly depending on a number of factors including rainfall within the watershed, yearly snowpack, recreational user needs, power production and minimum / maximum flow requirements. The Township is not responsible for the operation of the watershed and its control structures.

**Figure #2- Water levels on Ahmic Lake**

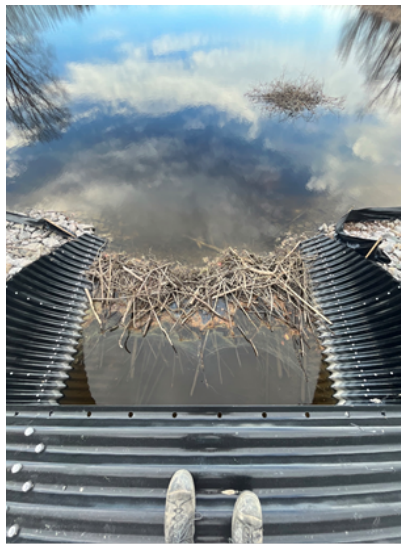
An additional contributing factor for water levels is the beaver activity in the area of the culvert. During the design period, it was identified that beavers were present with a lodge and feed bed next to the project location. At the time of the final inspection, it was noted that a beaver dam had been constructed across the newly installed culvert. Currently this beaver dam is restricting flow through the culvert.

**Figure 3 - Culvert Facing Northwest – Beaver dam obstruction**

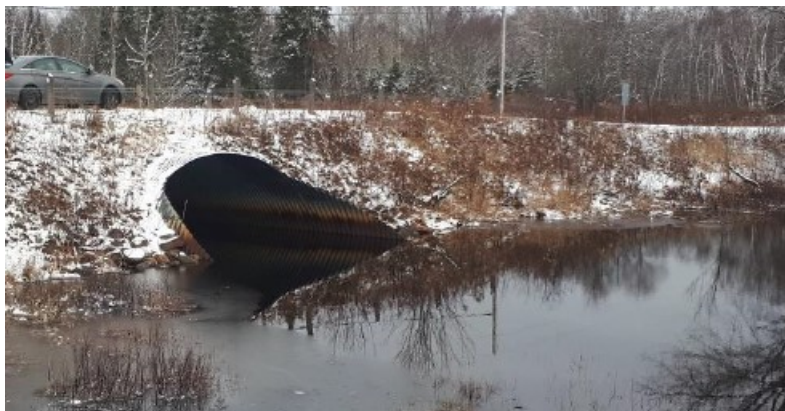
The original culvert was a 6500 mm wide x 3600 mm tall elliptical CSP structural steel plate. The existing inverts for this culvert were as follows:

NW Invert: 271.17 m

SE Invert: 271.15 m

**Figure 4 – Existing CSP Elliptical Culvert**

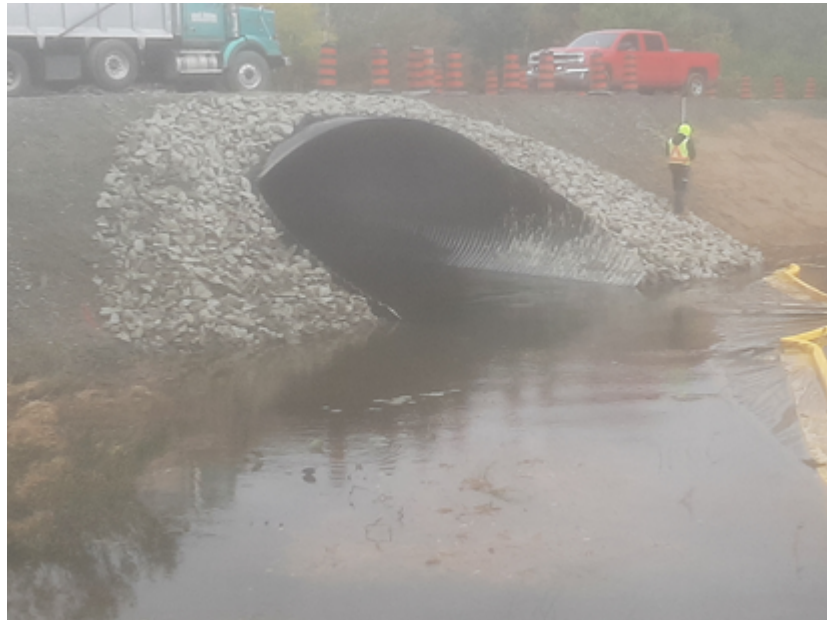
The culvert installed as part of this design was a 6450 mm wide x 3910 mm tall polymer coated CSP ellipse culvert with the following inverts.

NW Invert: 270.871 m

SE Invert: 270.864 m

**Figure 5 – New Polymer-Coated CSP Ellipse Culvert**

A higher, or taller, culvert was selected based on the available products that best matched the original culvert. Since this new culvert had a greater height, it was embedded approximately 275 mm lower than the existing culvert to achieve similar hydraulics. It should be noted that homeowners on West Poverty Bay may have documented significant water level changes during construction. This may have occurred due to the fact that only two small culverts were used as a temporary flow bypass during the construction period.
