Structure Name:	Bay street bridge - Bridge #10		
Main Hwy. / Road #:	Bay Street	On <input checked="" type="checkbox"/> Under	Crossing Type: Navig. Water
Highway / Road Name:	Bay Street		
Structure Location:	0.5 km W of Highway 520		
Easting	17 605251	Northing	5057500
Owner(s):	Municipality of Magnetewan	Heritage Designation:	Not cons.
MTO Region:	Northeastern Region	Road Class:	200
MTO District:	Huntsville	Posted Speed:	80
		No. of Lanes:	2
Old County:		AADT:	105
		% Trucks:	
Geographic Twp.		Inspection Route Sequence:	
Structure Type:	Other - Undefined	Interchange Number:	
Total Deck Length:	6.9 m	Interchange Structure No.	
Overall Str. Width:	9.3 m	Min. Vertical Clearance:	m
Total Deck Area:	64.17 m ²	Special Routes:	N/A
Roadway Width:	7.3 m	Detour Length Around Bridge:	km
Skew Angle:	0 deg.	Direction of Structure:	E-W
No. of Spans: Span	1	Fill on Structure:	m
Lengths:	6.6 m

Field Inspection Information:			
Date of Inspection:		Type of Inspection:	OSIM
Inspector:	Kevin Hawley, P.Eng.		
Others in Party:			
Access Equipment Used:	Camera, Measuring Tape (3m), Boots, Hat, Gloves, Vest, Inspection Forms and Clip Boards		
Weather:	Sunny		
Temperature:	20 °C

BRIDGE PHOTOGRAPHS

Struct

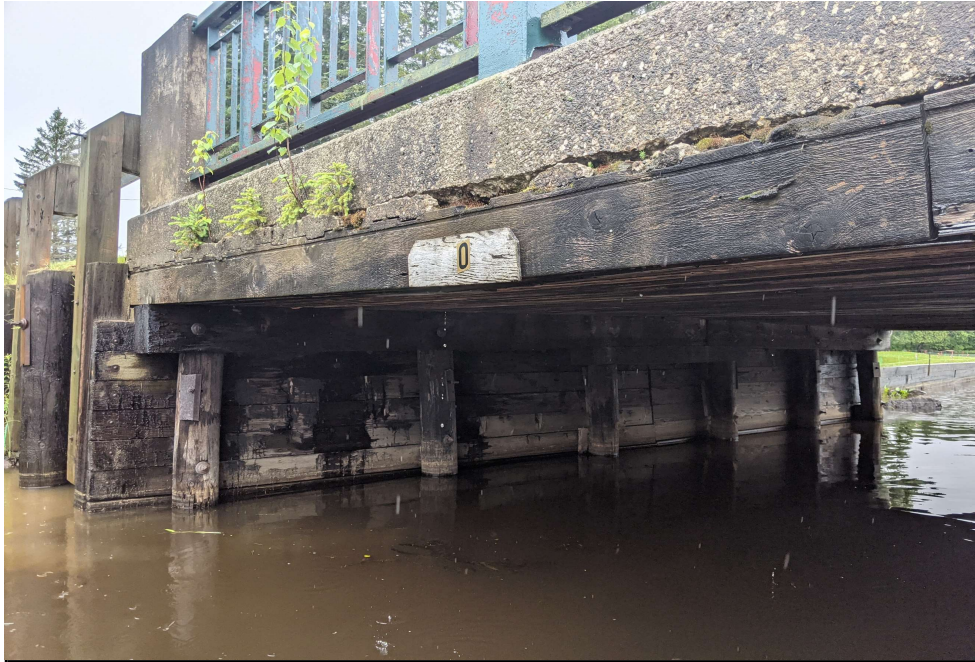
Photo 1: Damaged Soffit And Piles

Recommended Work on Structure:	Replace
Timing of Recommended Work:	Now
Overall Comments:	2 of 6 Piles on west side show signs of failure
	1 of 6 piles on on east side shows signs of failure
	Concrete overlay is failing
	Wood deck is sagging on North Side
Date of Next Inspection:	2025

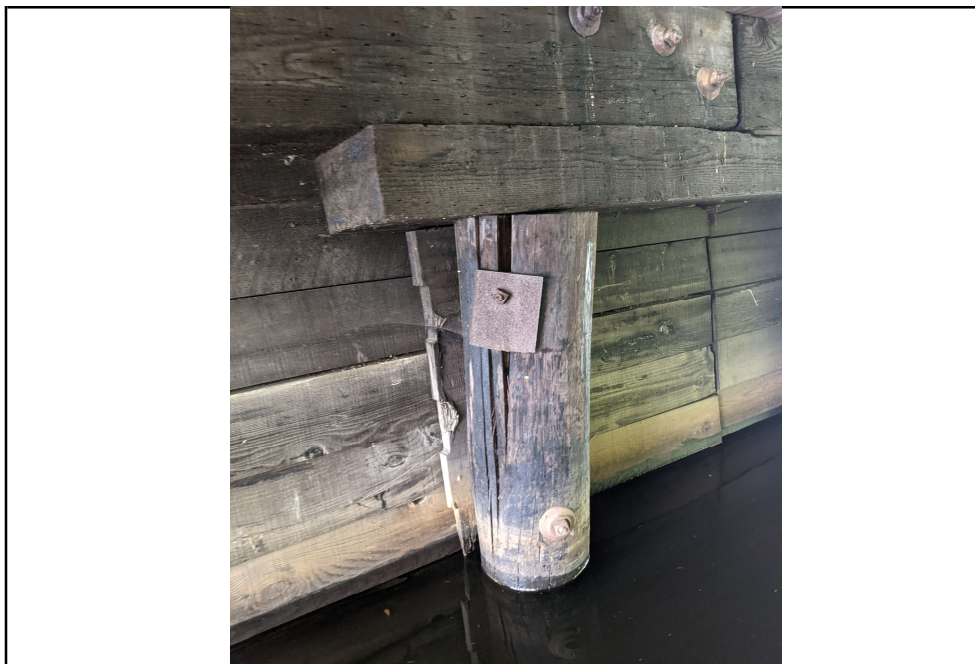
Photo 2: Failing Pile

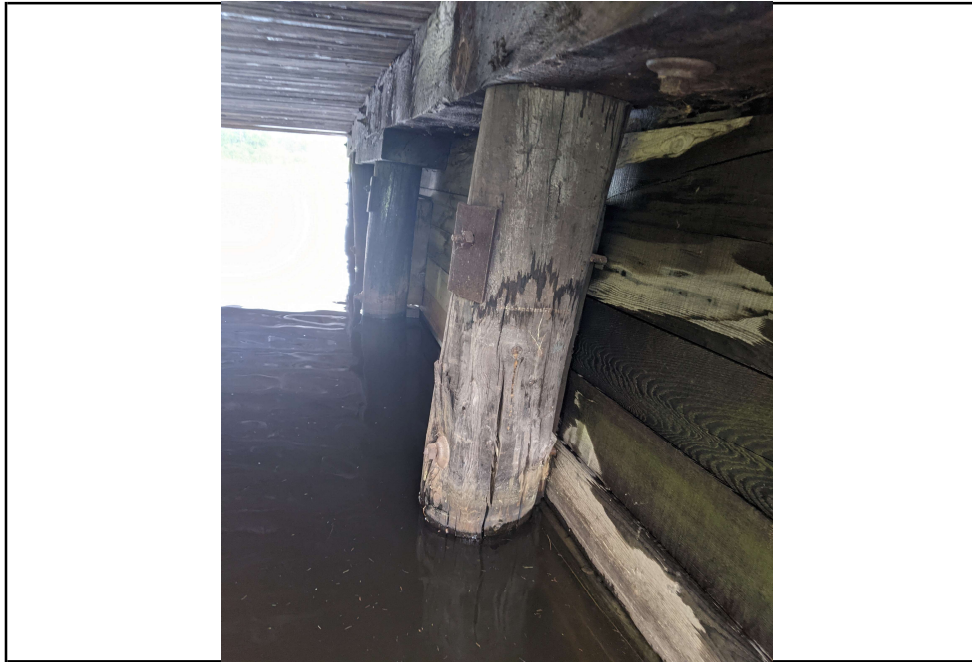
Photo 3: Failing Pile

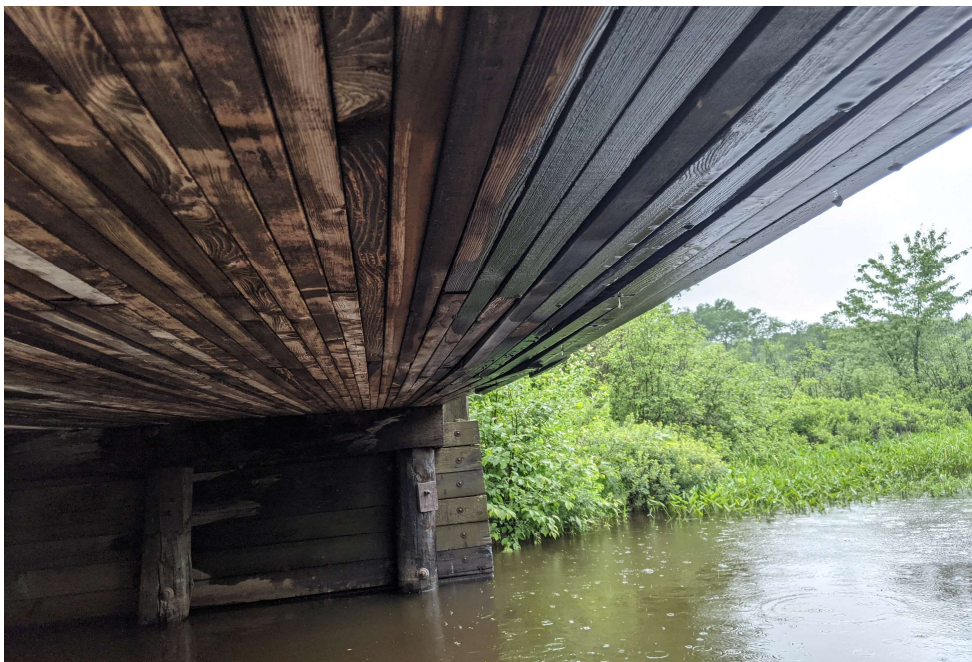
Photo 4: Sagging of Soffit
