## **Functional Service Report**

Sewage Infrastructure for RV Park  
Ahmic Lake Resort  
50 Robinson Dr, Magnetawan, ON P0A 1P0

Date:  
30 April 2025

Prepared by:  
Charles Cooper BCIN 511856  
Muskoka Hydrovac Ltd. BCIN 207776

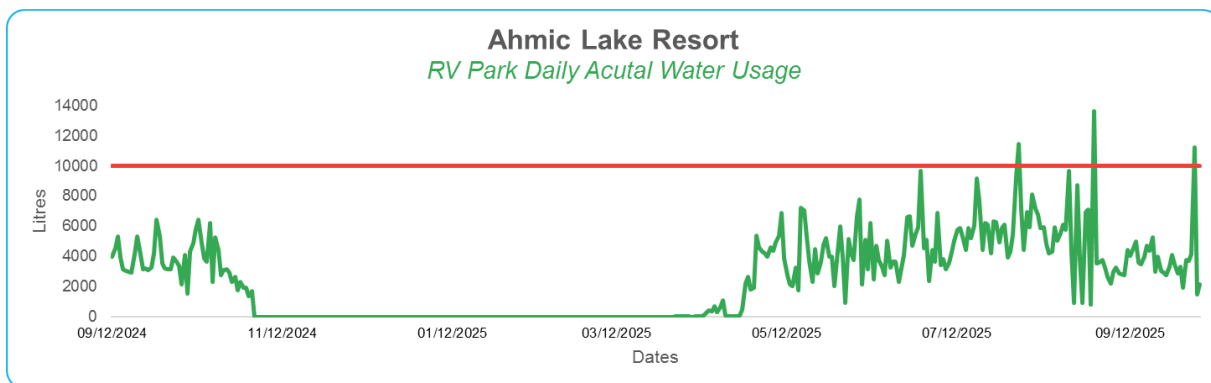
This chart indicates the daily flow rate has only exceeded 10,000 liters per day on three occasions. Due to the variability of this data, using the average of the top 100 days (over both 2024 and 2025) or the median are not realistic, with the respective values being an average of 5872 and a median of 5406 liters. The best way to analysis this dataset is using the 95<sup>th</sup> percentile calculation. A good practice to control for outliers

is found within Statistics, which captures the flow for the top 100 days of both 2024 and 2025 and then determine the 95<sup>th</sup> percentile. The result of this calculation demonstrated that the 95<sup>th</sup> percentile was on Thursday the 21<sup>st</sup> of August, 2025, the daily rate of water consumption on that day was 9671 litres. For this report I have rounded this value up to 9700 liters per day and will use it for all alternative solution calculations.

The daily water report did show abnormal peaks, which appear to align with long weekends where guests most likely power washing their units, boats and cars as well operating lawn sprinklers. A recommendation to the owner would be to restrict the use of the water for such activities on weekends. The daily water report also did not indicate if there were any known water or plumbing issues in the RV area of the park on these dates. The following conditions would also generate abnormal usage patterns, such as broken water lines, malfunction fixtures etc.

For this alternative solution I would propose grandfathering the current system, implement the recommendations in this report and use the 95<sup>th</sup> percentile calculated value of 9700 liters per day as the daily flow rate. This rate is much higher than the average value for the busiest 100-day period which is 5872 liters per day.

Signage within the park advising guests and staff to conserve water on weekends, including banning the washing of trailers, buildings, vehicles or boats. This will help limit the park from exceeding 9700 litres per day of capacity and staying well within the design parameters of the proposed alternative solution.
