### GEOTECHNICAL INVESTIGATION REPORT

Bay Street Bridge Replacement

Magnetawan, ON

TULLOCH Document No. / Rev. 26-0649-2050-001 / Rev. 0  
April 2026

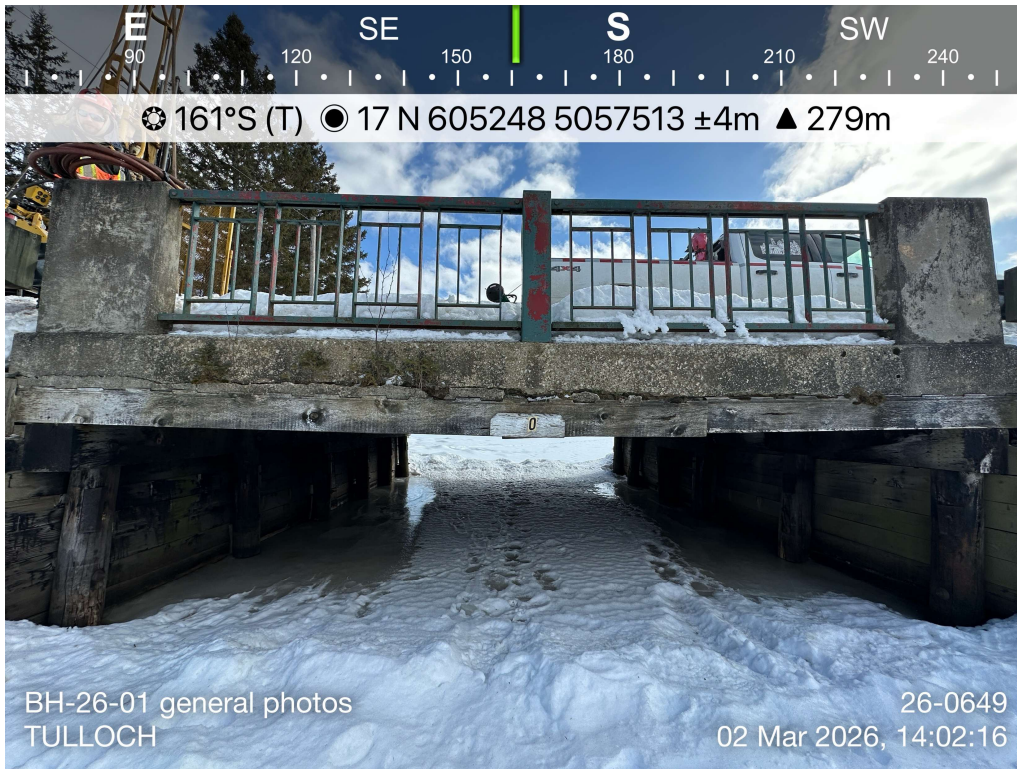
Photo 1: Existing Bridge – North Side.

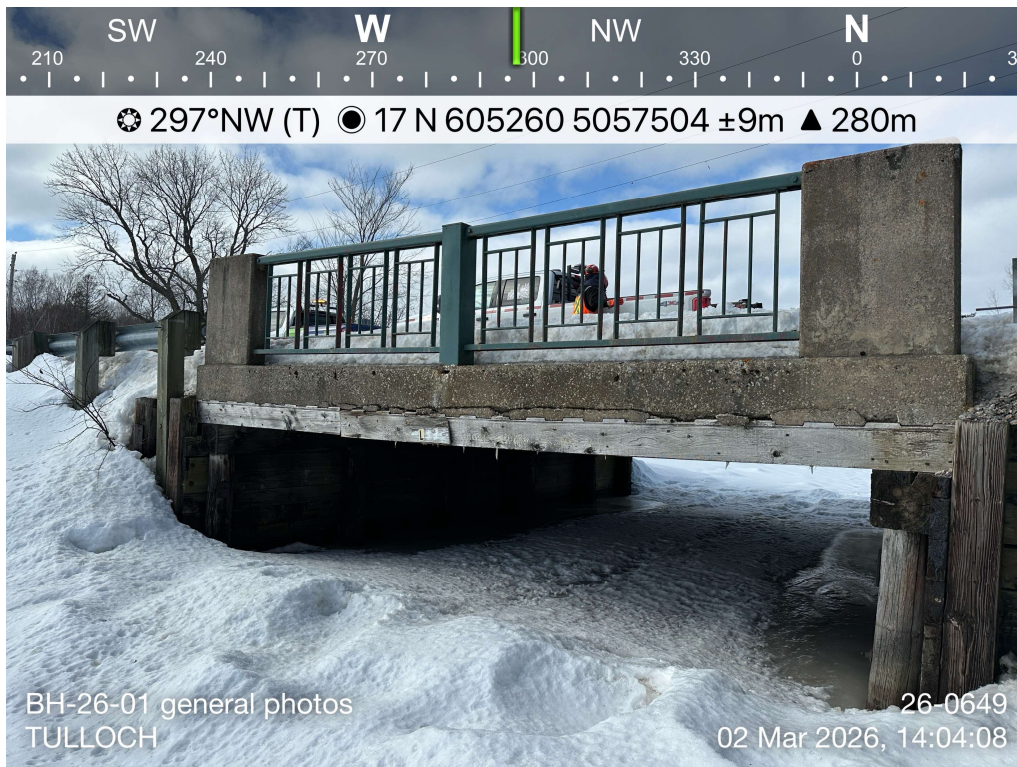
Photo 2: Existing Bridge – South Side.

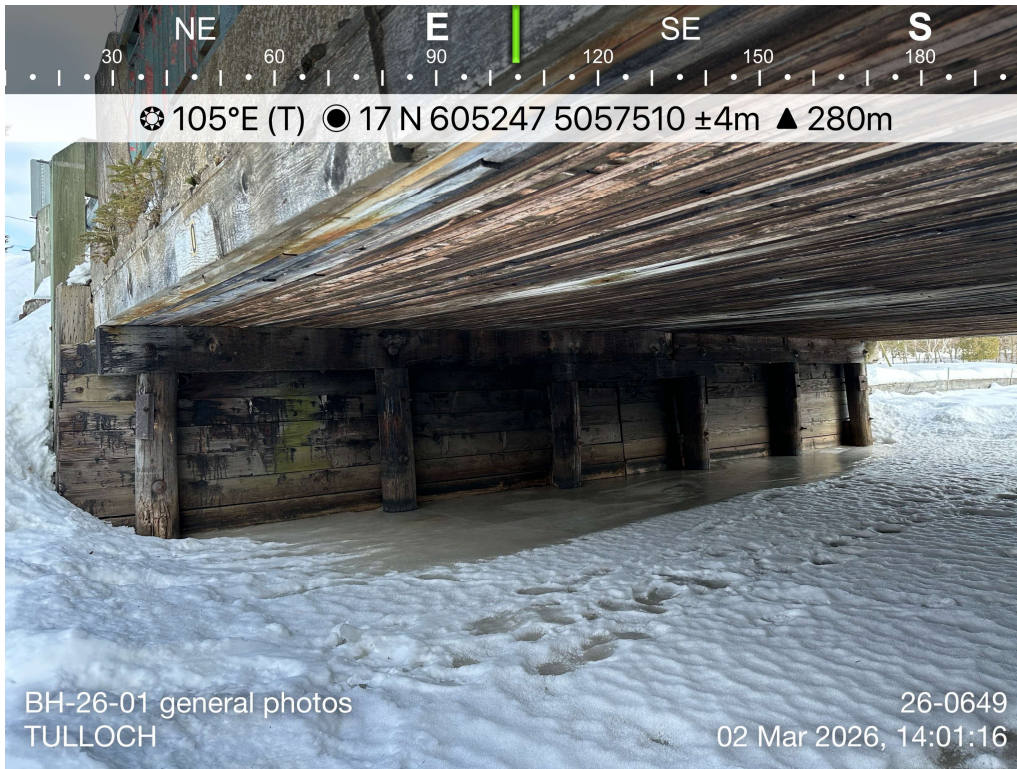
Photo 3: Existing Bridge – East Abutment.

The existing Bay Street Bridge is a two-lane, single span bridge with a cast-in-place concrete deck supported on timber beams connected to a series of six (6) timber piles at each abutment. Review of the most recent available OSIM report in 2023 indicates that the timber piles are failing, and generally the bridge has reached the end of its service life. The report recommended the bridge for replacement. As such, the geotechnical recommendations in this report are tailored to full replacement of the structure.

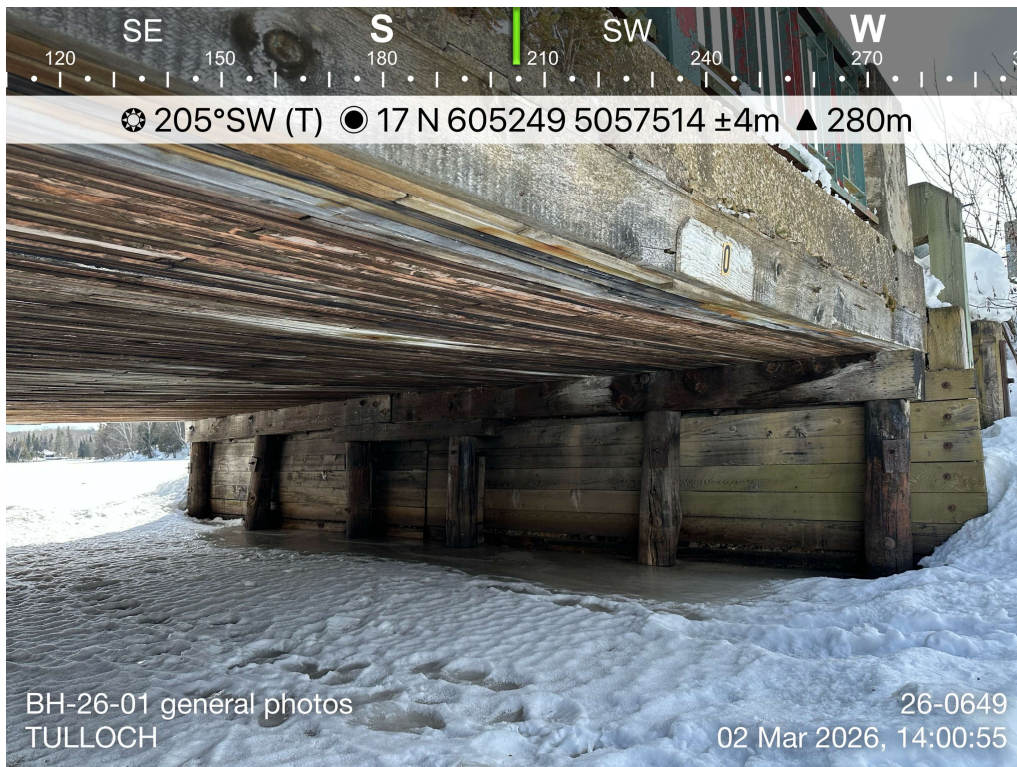
Photo 4: Existing Bridge – West Abutment.

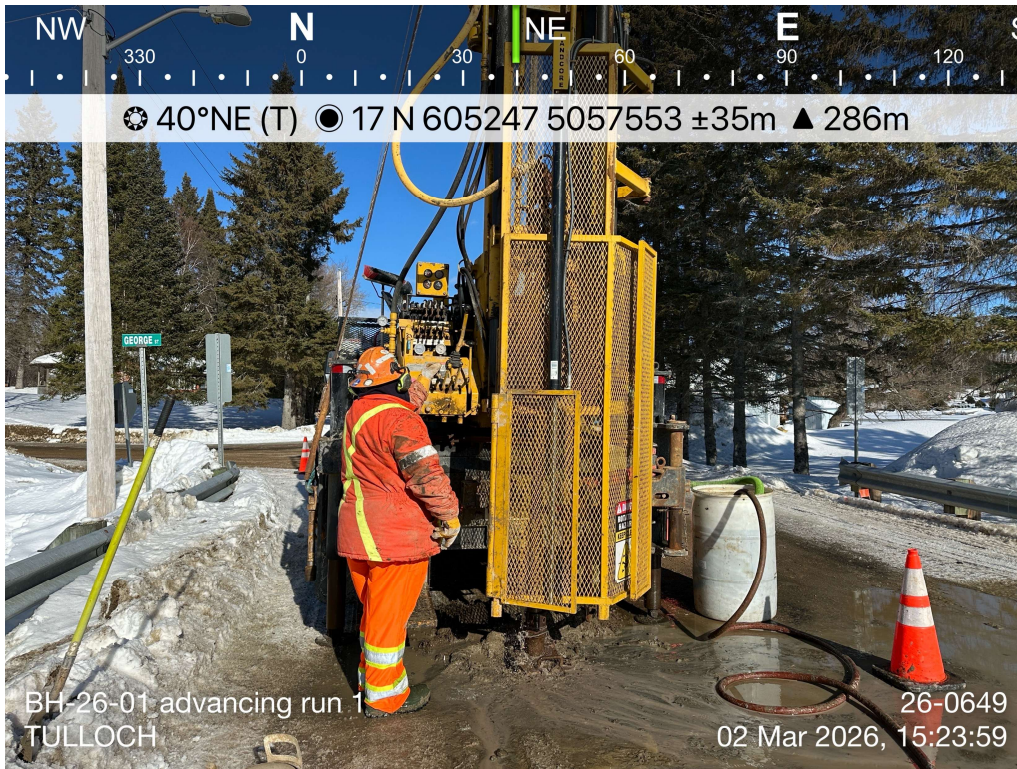
Photo 5: BH-26-01 during advancement. Photo taken facing northeast.

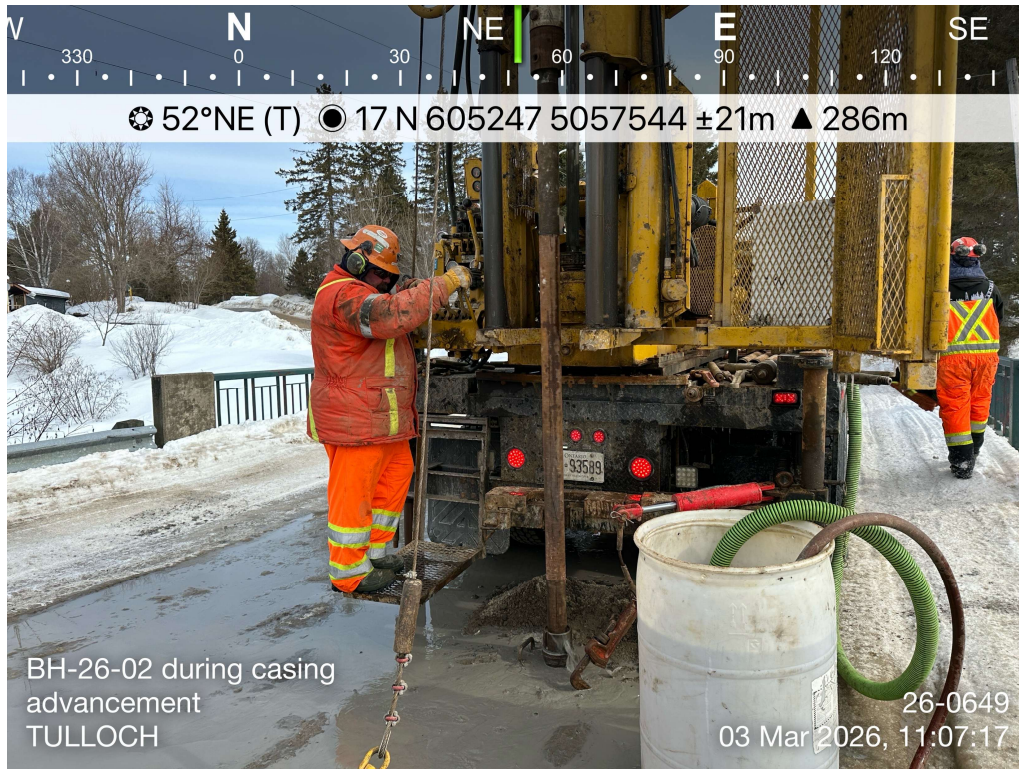
Photo 7: BH-26-02 during advancement. Photo taken facing northeast.

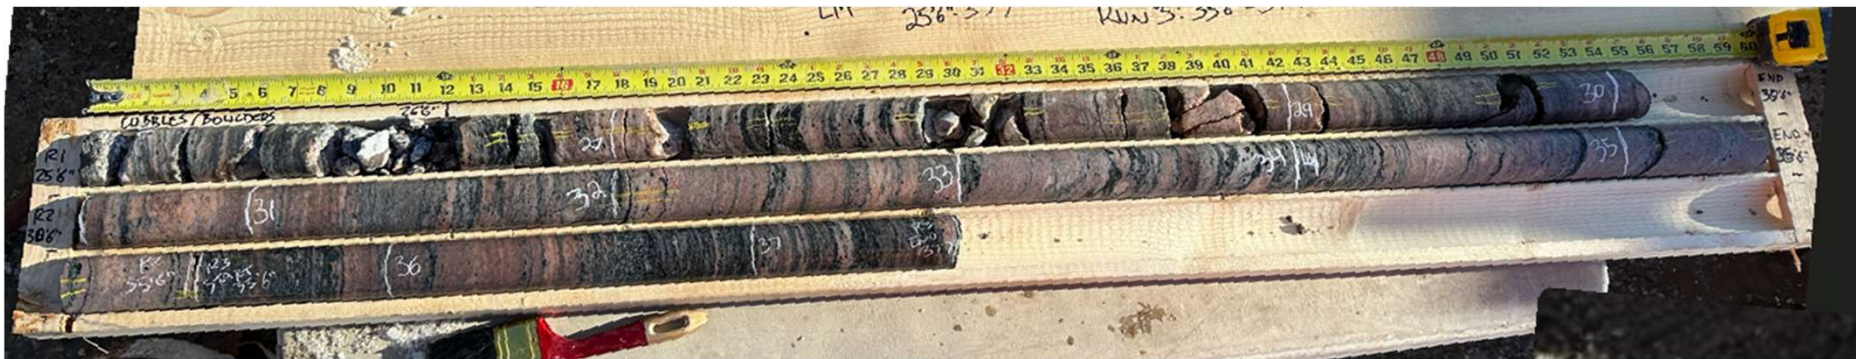
# Retrieved Rock Core at Borehole Location BH-26-01

Top of Bedrock Elevation: 8.08 mbgs / 273.24 masl

Bottom of Core Elevation: 11.46 mbgs / 269.86 masl

Bedrock was cored in BH-26-01 and BH-26-02 and inferred in BH-26-03 and BH-26-04 based on auger and split spoon refusal. The bedrock conditions were consistent, with banded gneissic bedrock encountered at both borehole locations. The orthogneiss was generally red to pink with dark grey to light grey banding observed throughout the retrieved cores. The bedrock was fine to coarse-grained. A fragmented zone with trace sand filling and oxidation was observed in BH-26-02 from approximately 9.5 to 9.7 mbgs. The bedrock was fresh to faintly weathered with drill induced fractures throughout.

The calculated RQD for the retrieved rock cores ranged from 72% to 100%, indicating the observed rock mass was of fair to excellent quality. The calculated TCR ranged from 72% to 100%, and the calculated SCR ranged from 47% to 100% for the retrieved core runs.

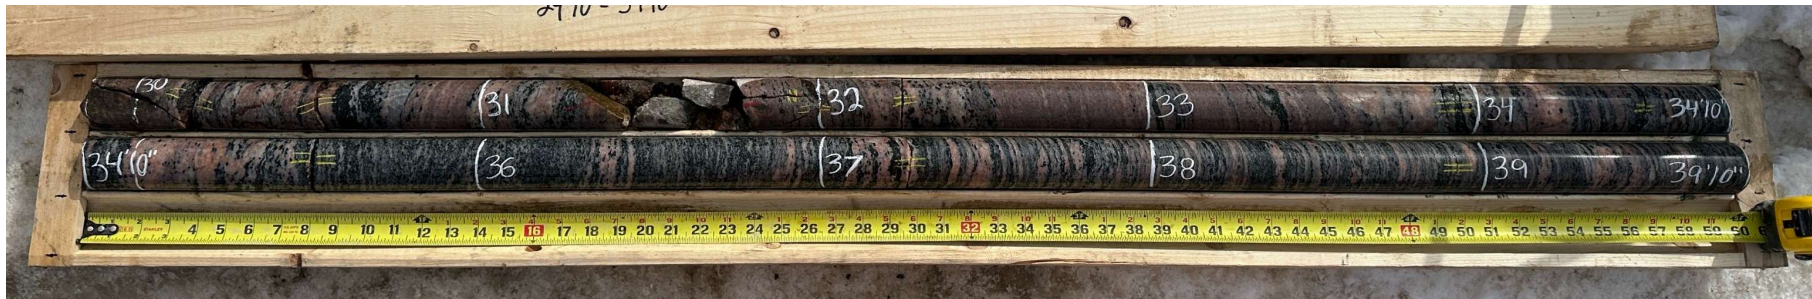
# Retrieved Rock Core at Borehole Location BH-26-02

Top of Bedrock Elevation: 9.09 mbgs / 272.01 masl

Bottom of Core Elevation: 12.14 mbgs / 268.96 masl
