Michalski Nielsen

Re: Scoped EIS and Lake Capacity/Water Quality Impact Assessment in Relation to a Proposed Severance of an Existing Cottage Lot at 184 Silver Lake Road, Municipality of Magnetawan, with Shoreline Frontage on Bells Lake (also known as Silver Lake) (Brandon and Ashley Cordua); Our File 0624

SEVERANCE SKETCH

184 SILVER LAKE ROAD
PARTS 8 TO 13 PLAN 42R-12527
PART OF LOT 13, CONCESSION 14
GEOGRAPHIC TOWNSHIP OF SPENCE
TOWNSHIP OF MAGNETAWAN
DISTRICT OF PARRY SOUND

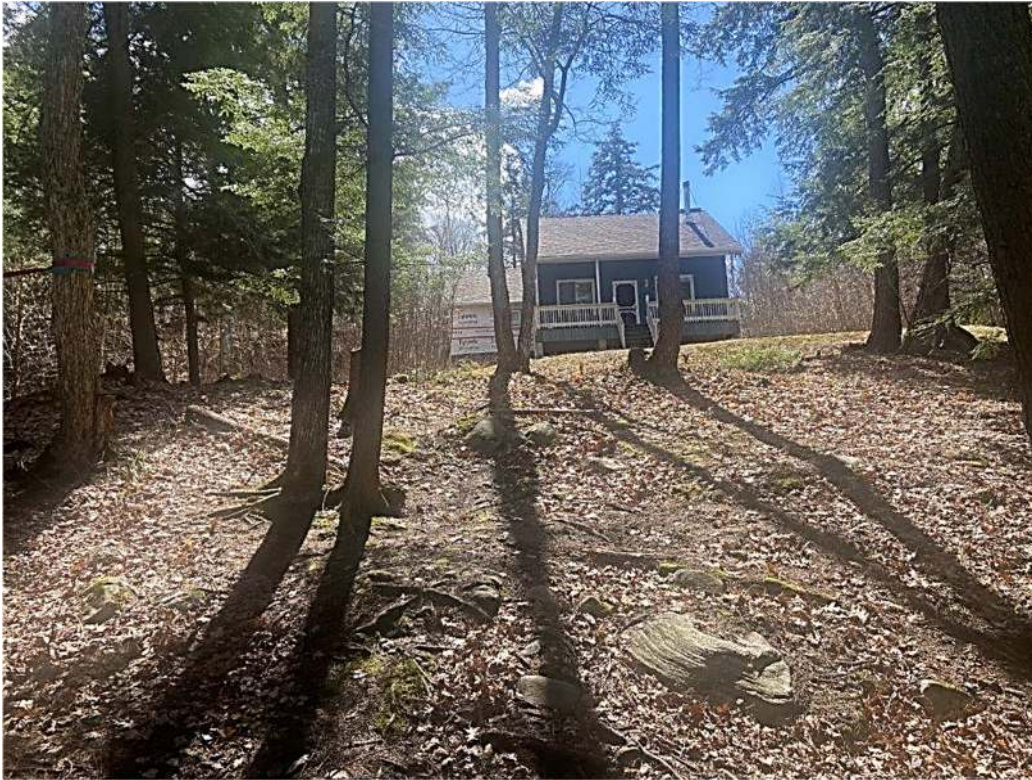
Photograph 1. View of existing cottage on proposed retained lot (April 10, 2024).

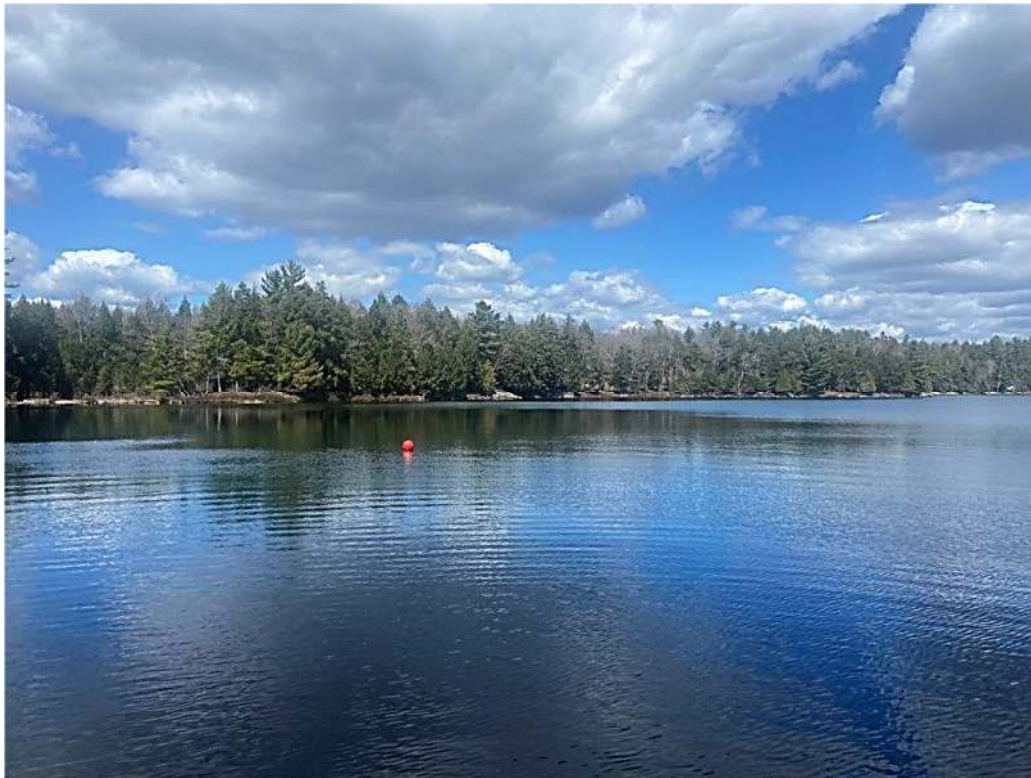
Photograph 2. View of Bells Lake from subject lands; this portion of lake is quite undeveloped (April 10, 2024).

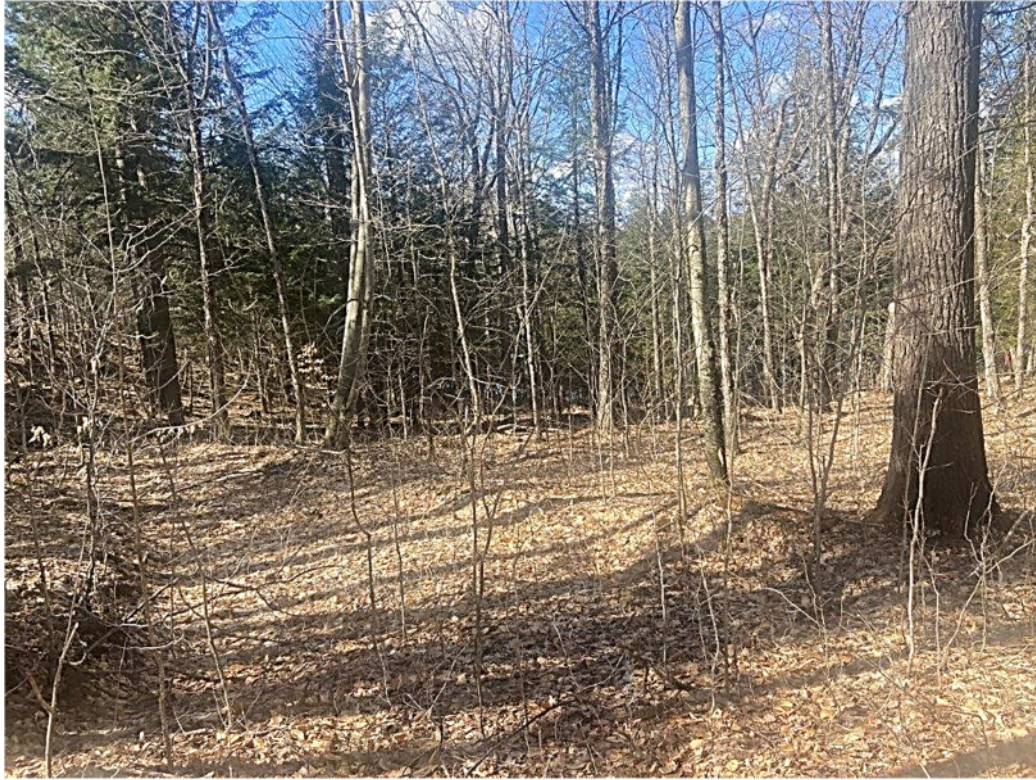
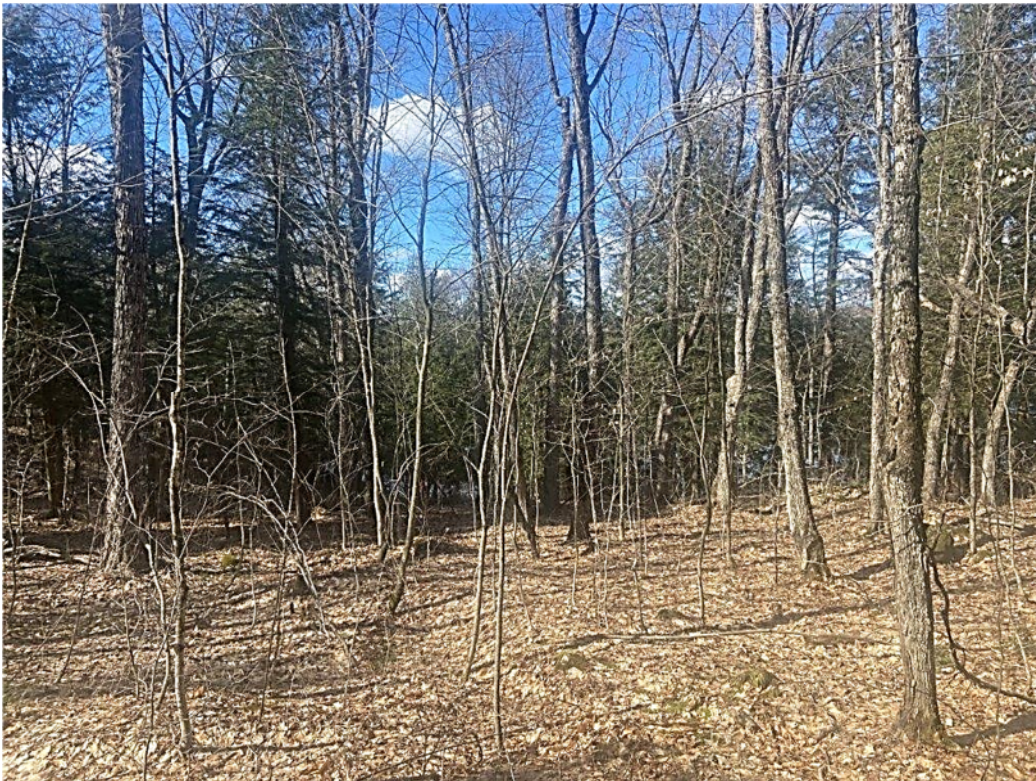
Photographs 3 and 4. Views of recommended building envelope on proposed severed lot, set back a minimum 30 m from the shoreline on moderate sloping, well-drained land (April 10, 2024).

Photographs 3 to 6 provide views of the recommended building envelope on the proposed severed lot, which is also shown on the Severance Sketch. This is located on the western side of this proposed lot, a minimum 30 m back from the shoreline, taking advantage of the well drained, gentle to moderate terrain in the area. It consists of Sugar Maple dominated deciduous forest, with some American Beech and with scattered Eastern Hemlock. Slopes are $\pm 15\%$ across this area, making it an easy location to build on, as well as to install a sewage disposal bed (note that the building envelope has been sized such that the sewage disposal can be located within it). Conditions in this area are preferable to the western portion of the lot, where slopes are more uneven and often steeper, and where ground conditions are rockier.

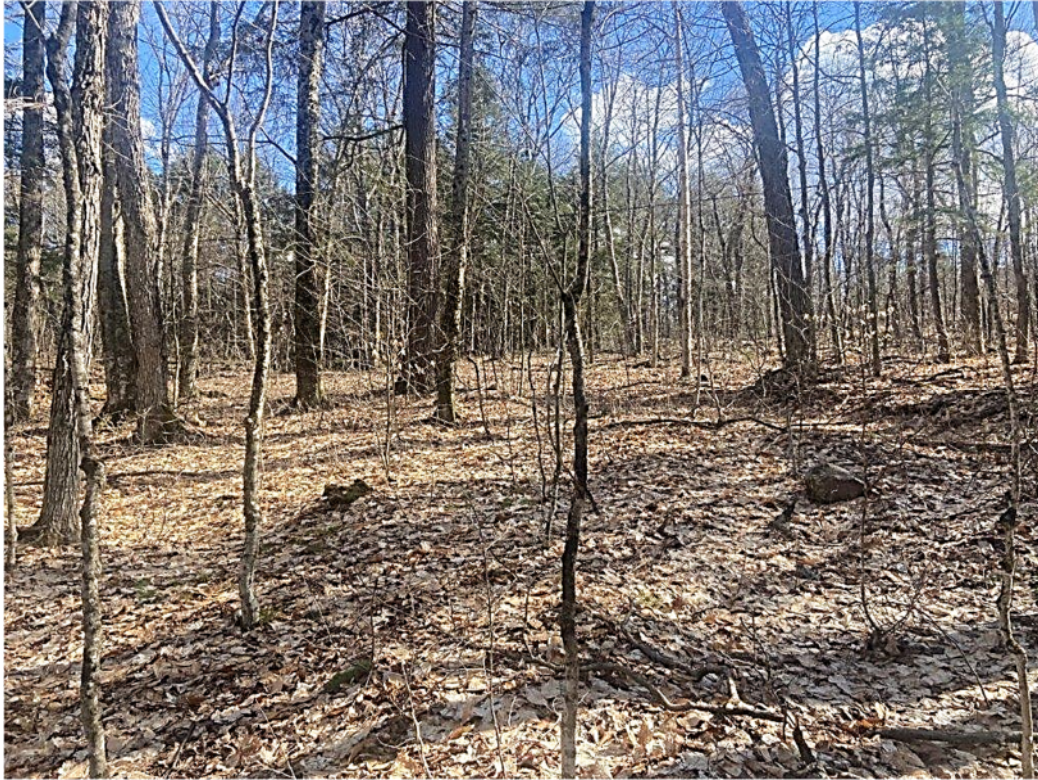
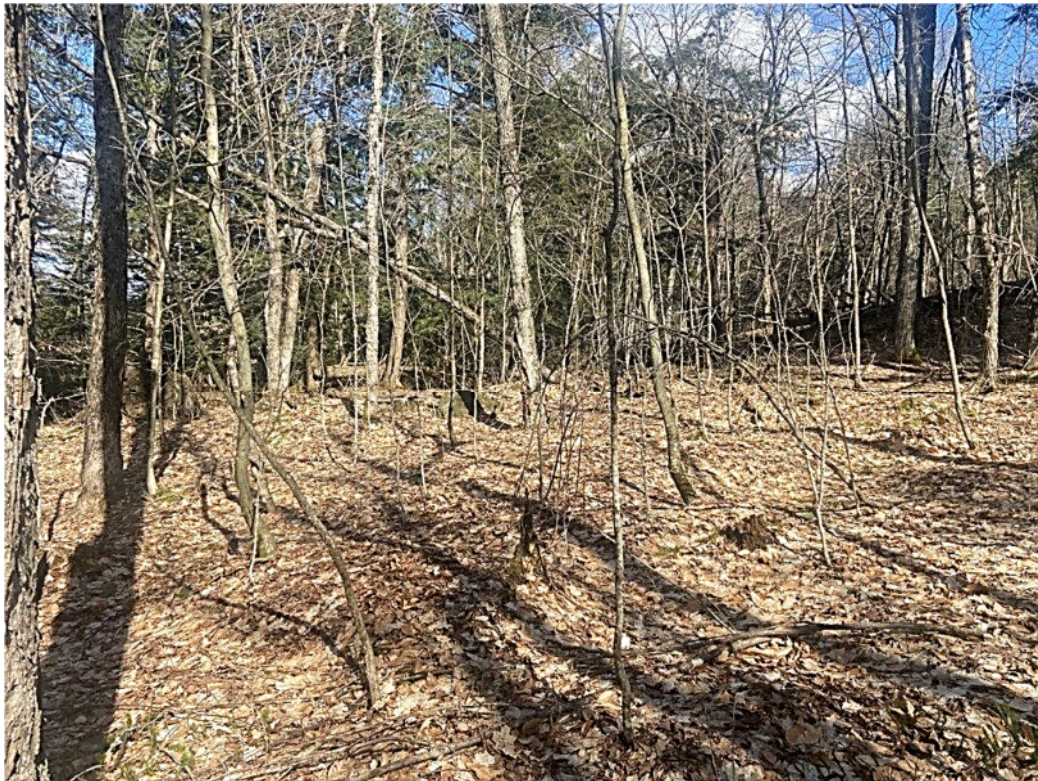
Photographs 5 and 6. Additional views of recommended building envelope on proposed severed lot (April 10, 2024).

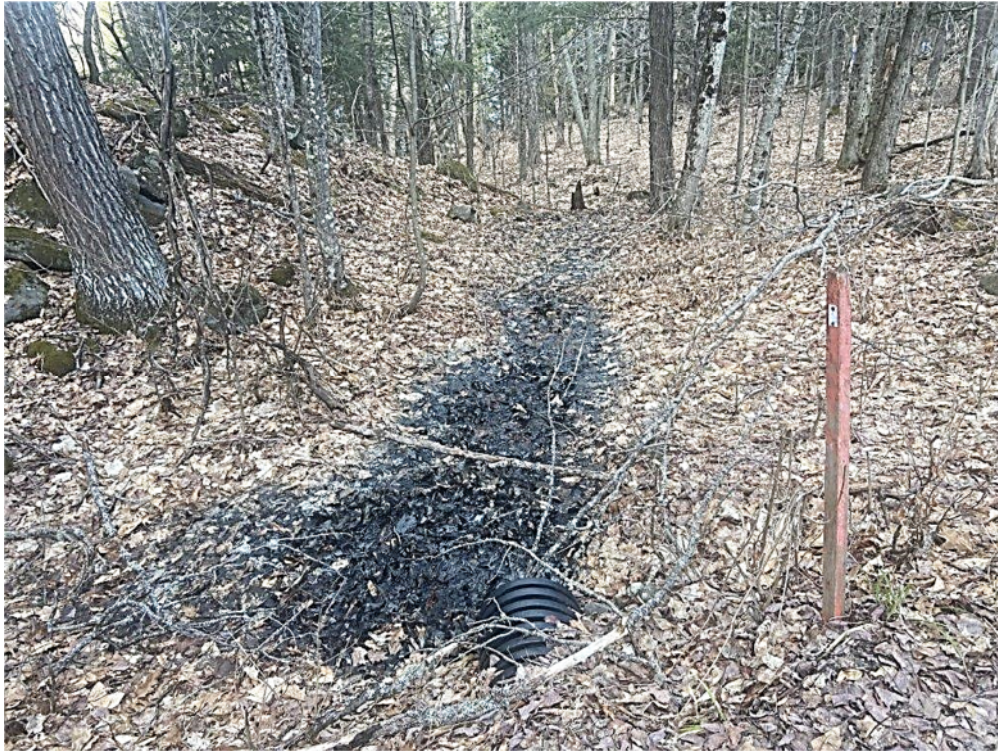
Photograph 7. A small rock ridge creates a logical divide between proposed retained land, to left, and proposed severed land, to right. Note that recommended building envelope on the proposed severed lot avoids area of ephemeral drainage created by localized culverted runoff (not a watercourse) (April 10, 2024).

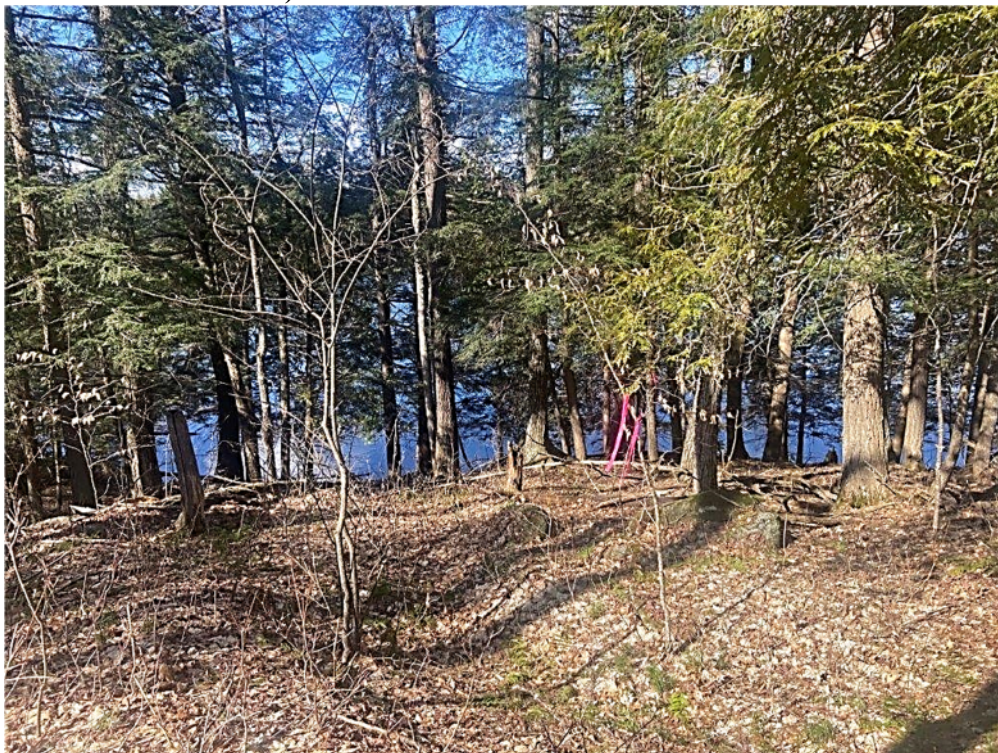
Photograph 8. Recommended 30 m cottage setback on proposed severed lot is shown with flagging tape. The slope increases within the riparian zone down to the lake (April 10, 2024).

On the proposed severed lot, we are recommending a 30 m structural setback from the shoreline, both as part of a precautionary approach to the protection of water quality and because slopes steepen within 30 m of the shore. With regards to the latter, the pink flagging tape on **Photograph 8** shows the 30 m setback from the lake in front of the proposed building envelope. **Photographs 9 and 10** provide views of the steeper nature of the shoreline riparian area, with the pink flagging showing the 30 m setback also being evident in **Photograph 10**. As is clear from these photographs, the 30 m shoreline riparian area is dominated by Eastern Hemlock, with some Eastern White Cedar, particularly closer to the shoreline. The riparian zone also contains some Sugar Maple, beginning 10 m back from the shore. **Lands within 30 m**

- the foundation of the dwelling is to be a minimum 30 m back from the shoreline, with a 5 m allowance (i.e., a minimum 25 m back from the shoreline) for decks, patios and hard landscaping;

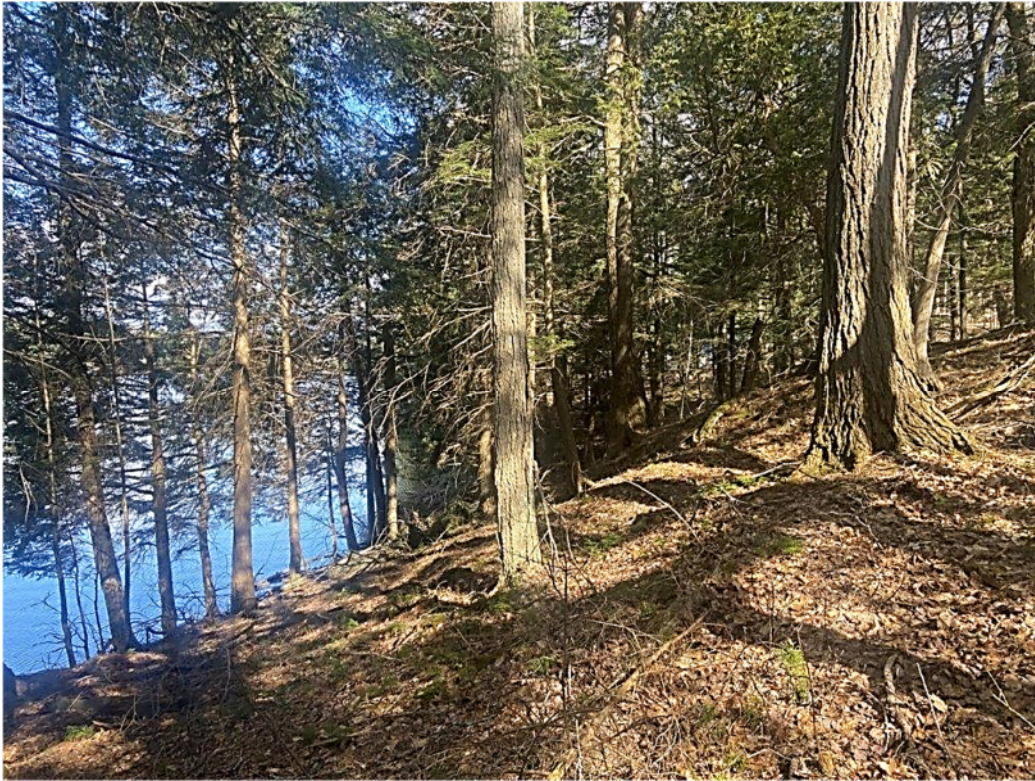
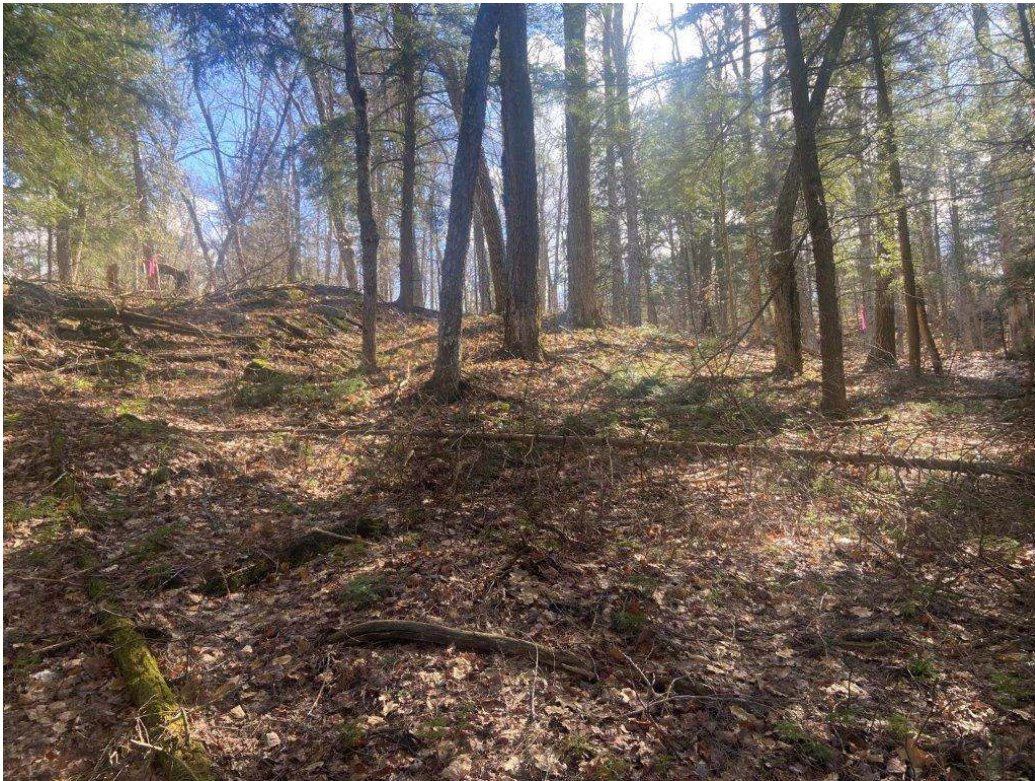
Photographs 9 and 10. Additional views of shoreline riparian zone, which can be easily traversed with a pathway (April 10, 2024).

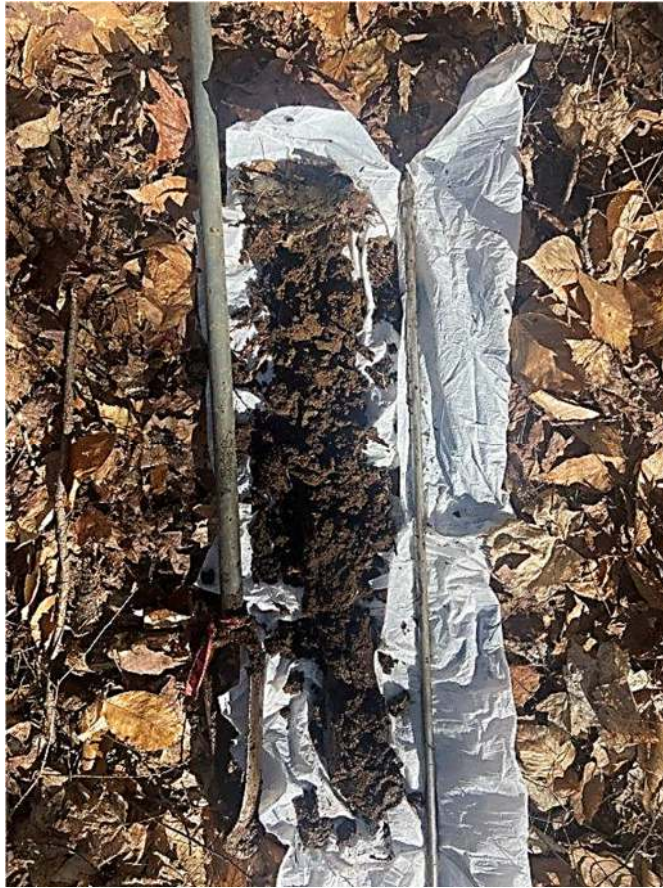
A soil core was taken within the western portion of the proposed building envelope, at a distance of 50 m from the shoreline, with that profile shown in **Photograph 11** and described in **Table 1**. There is a very well developed and deep ‘B’ horizon, which is very well drained over the top ~60%, with some seasonal moisture in the lower ~40%. That ‘B’ horizon is well mineralized to depth, with its orange-brown colour being indicative of the presence of abundant iron and aluminum, and signifying its high capacity to adsorb and permanently mineralize phosphorus (see Section 5.0 of this report for further discussion of the importance of soils with these properties in immobilizing phosphorus and preventing it from reaching the lake). While no laboratory analyses were completed of the soils from this property, we are confident from our examination of them that they have a high phosphorus retention capacity.

Photograph 11. Soil profile from one of several areas within proposed building envelope that would be suitable for a sewage disposal bed (April 10, 2024).

Table 1. Soil Characteristics in General Location of Proposed Sewage Disposal Bed.

Depth (m)	Soil Characteristics
0.00 – 0.03	Humic layer; comprised of decomposing leaves
0.03 – 0.10	‘A’ horizon; organic-rich, dark brown coloured, silty sand
0.10 – 0.42	‘B ¹ ’ horizon; orange-brown coloured, medium textured sand with some silt and minor gravel; well drained; well mineralized
0.42 – 0.65	‘B ² ’ horizon; orange-brown coloured, medium textured sand; seemingly well drained, but damp under early spring conditions; no mottling of soils seen, suggesting that dampness is very seasonal; remains well mineralized to depth
0.65	Refusal on hard pan

Through the combination of moving the septic system to a distance of 50 m back from the shoreline on the proposed severed lot, and by augmenting the depth of the naturally occurring good quality 'B' horizon soils to ensure a minimum 0.6 m depth of such soils in the construction of the sewage disposal bed, Michalski Nielsen Associates Limited is confident that there will be no potential for phosphorus from the sewage disposal system on this proposed lot to ever migrate to Bells Lake. Further, and per the recommendations of Section 7.0 of this report, other potential sources of phosphorus associated with both short term and longer term aspects of the development of the proposed severed lot can be properly controlled.

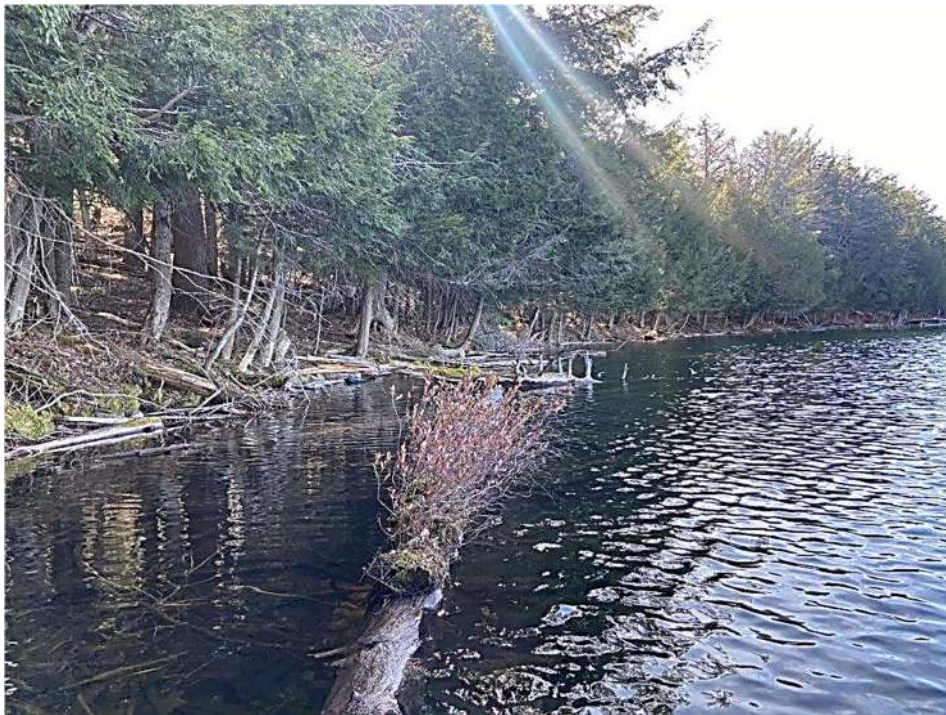
Photograph 12. Shoreline and nearshore of proposed severed lot, from east to west (April 10, 2024).

To assess fisheries constraints, a transect survey was completed across the nearshore of the proposed severed lot, using chest waders to examine nearshore slopes, substrate conditions and other elements of fish habitat. Onshore conditions were also recorded. **Figure 1** shows the locations of the six transects that were surveyed, with **Table 2** summarizing our findings. **Photographs 12 – 14** provide views of nearshore conditions. Nearshore slopes across the shoreline frontage of the proposed severed lot were in the range of 1:4 to 1:9, meaning that a water depth of 1 m (more than adequate for boat mooring on such a small lake) was encountered 4 m to 9 m offshore. Substrates consist of firm sand in the very nearshore, generally

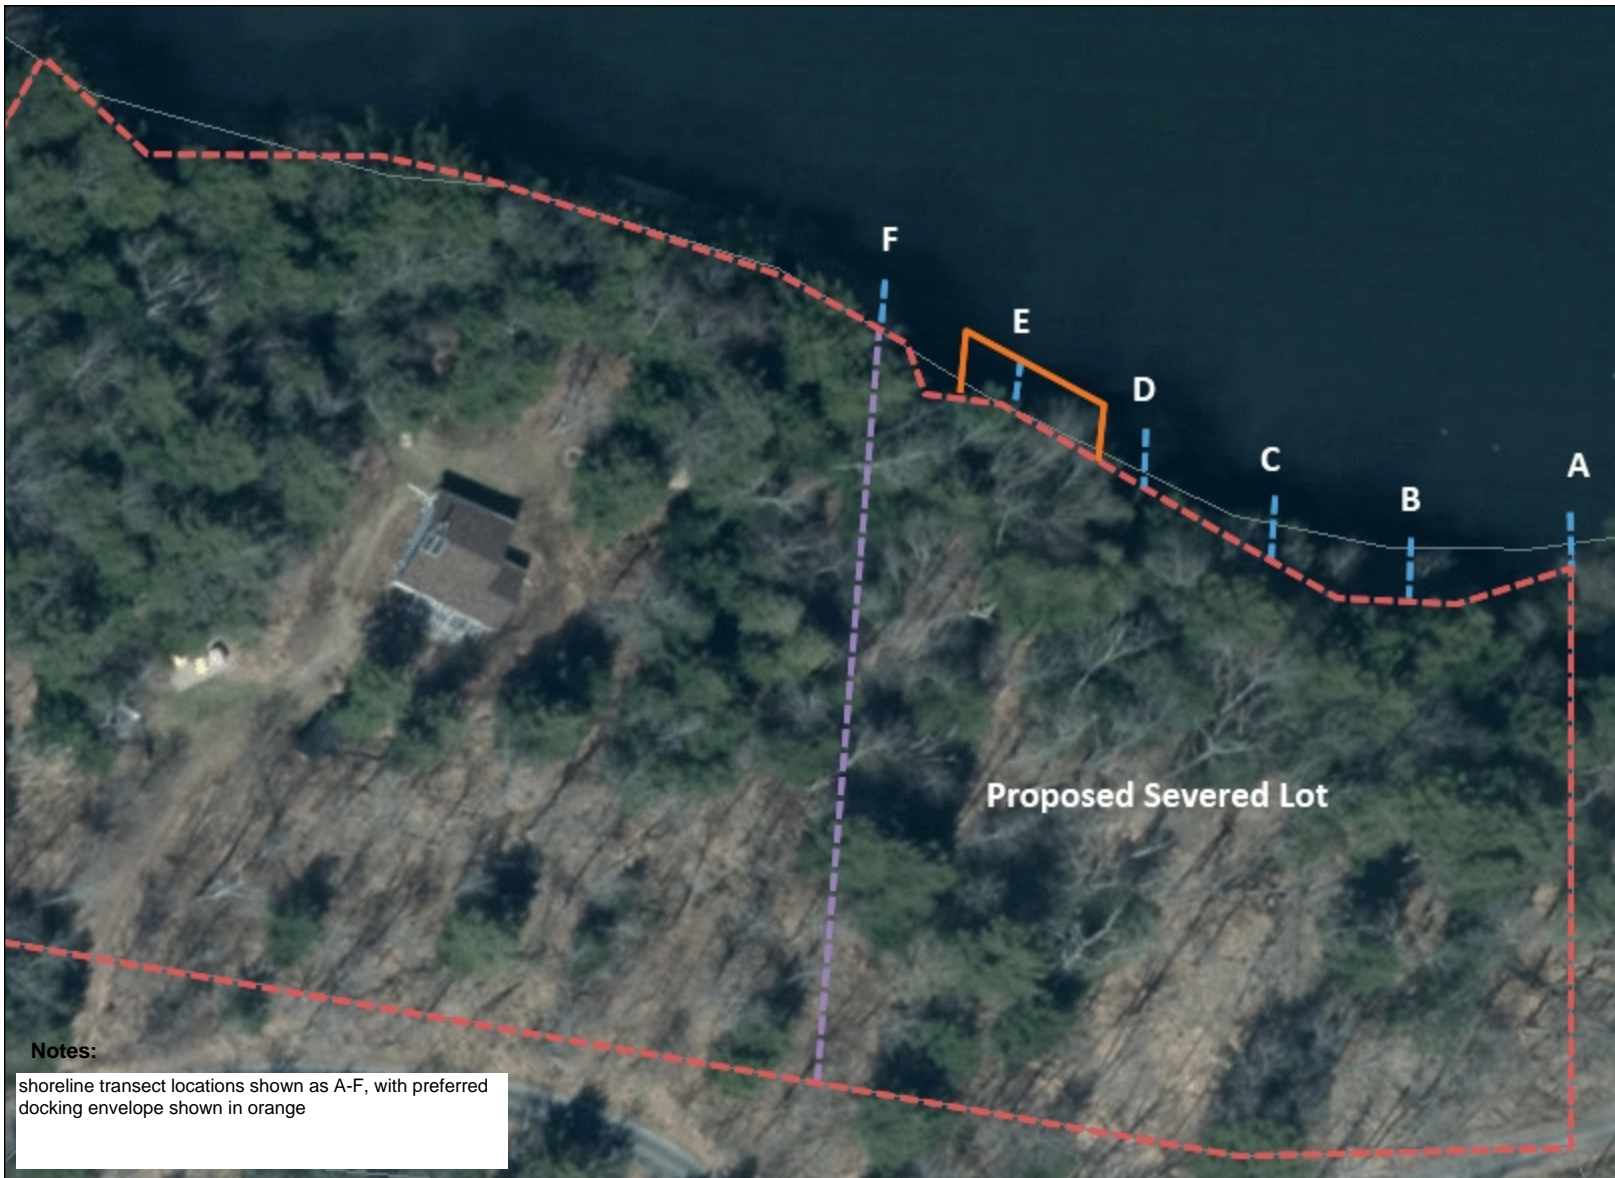
Notes:
 shoreline transect locations shown as A-F, with preferred docking envelope shown in orange

Table 2. Description of nearshore and shoreline conditions.

Transect	Nearshore slope	Substrates	Extent of aquatic vegetation	Other elements of cover	Nature of shoreline riparian area
A	1:8	Substantial amount of woody detritus over firm sand in the very nearshore; grading to soft silty sand about 5 m offshore	Scattered Pipewort and Floating-leaved Burreed	Very considerable amount of large logs and tree limbs	15% to 20% slopes to about 15 m back from shore, then steepening to 20% to 25%; hemlock dominated
B	1:6	Substantial amount of woody detritus over firm sand in the very nearshore; grading to soft silty sand about 3 m offshore	None seen	Very considerable amount of large logs and tree limbs	20% slopes to 20 m back from shore, steepening to about 30% further back; hemlock dominated
C	1:7	Substantial amount of woody detritus over firm sand in the very nearshore; grading to a medium firm sand about 5 m offshore	None seen	Very considerable amount of large logs and tree limbs	20% to 25% slopes to about 15 m from shore; steepening to about 30% further back; hemlock dominated

D	1:6	Substantial amount of woody detritus over firm sand in the very nearshore; grading to a medium firm sand about 4 m offshore	Some Pickerelweed to about 3 m offshore	Very considerable amount of large logs and tree limbs	±25% slopes to a distance of 30 m back from shore, then moderating; hemlock dominated
E	1:4	Substantial amount of woody detritus over firm sand in the very nearshore; grading to a medium firm sand about 4 m offshore	Moderate amount of Pipewort	Very considerable amount of large logs and tree limbs to 3 m offshore only, with scattered large woody material further offshore	±20% slopes, with good opportunities to install a very walkable pathway from a dwelling down to a dock; hemlock dominated
F	1:9	Substantial amount of woody detritus over firm sand in the very nearshore; grading to a medium firm sand about 7 m offshore	Some Pickerelweed to about 3 m offshore; moderate amount of Pipewort	Considerable amount of large logs and tree limbs to about 4 m offshore, with scattered large woody material further offshore	Somewhat hummocky terrain, with 20% to 30% slopes; hemlock dominated

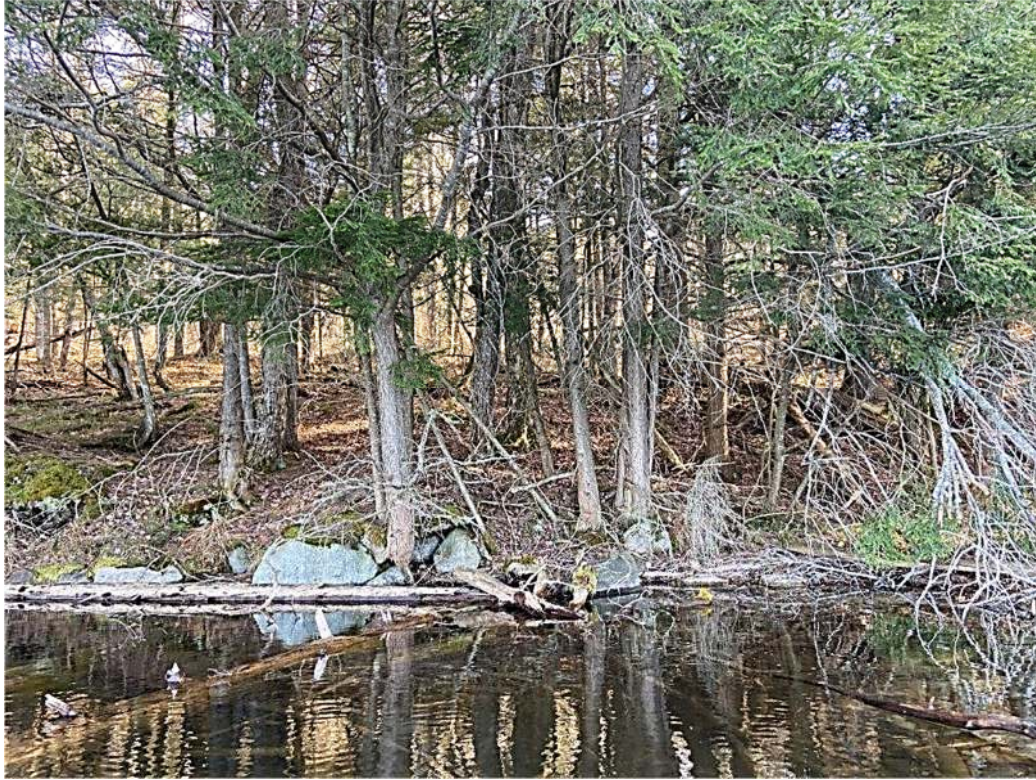
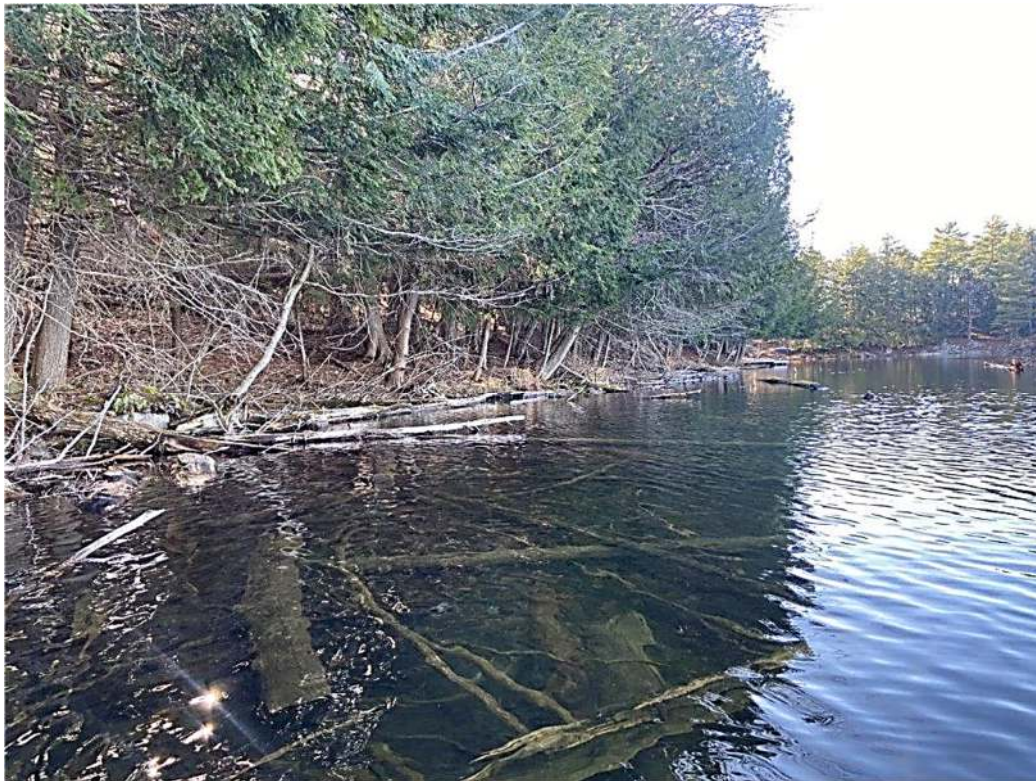
Photographs 13 and 14. Additional views of shoreline riparian zone and nearshore of proposed severed lot (April 10, 2024).

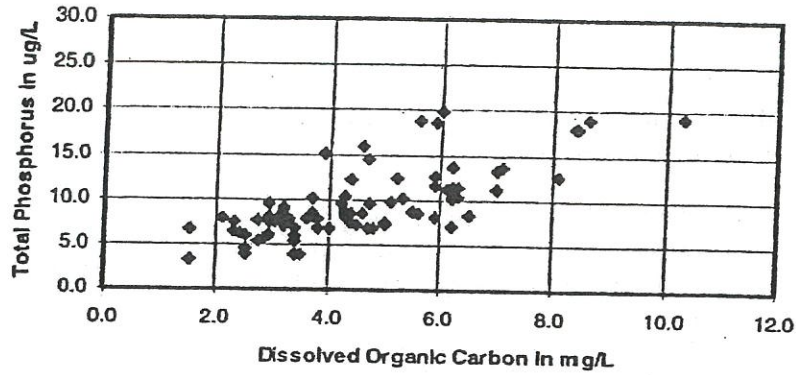
Figure II.17.3 Influence of dissolved organic carbon (DOC) on average long-term total phosphorus concentrations in Precambrian Shield lakes.

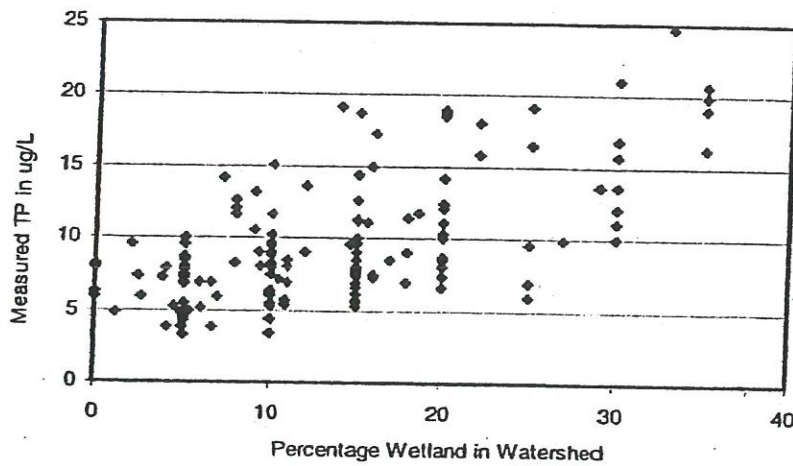
Figure II.17.4 Relationship of average long-term measured phosphorus in Precambrian Shield lakes with wetland area in catchment.

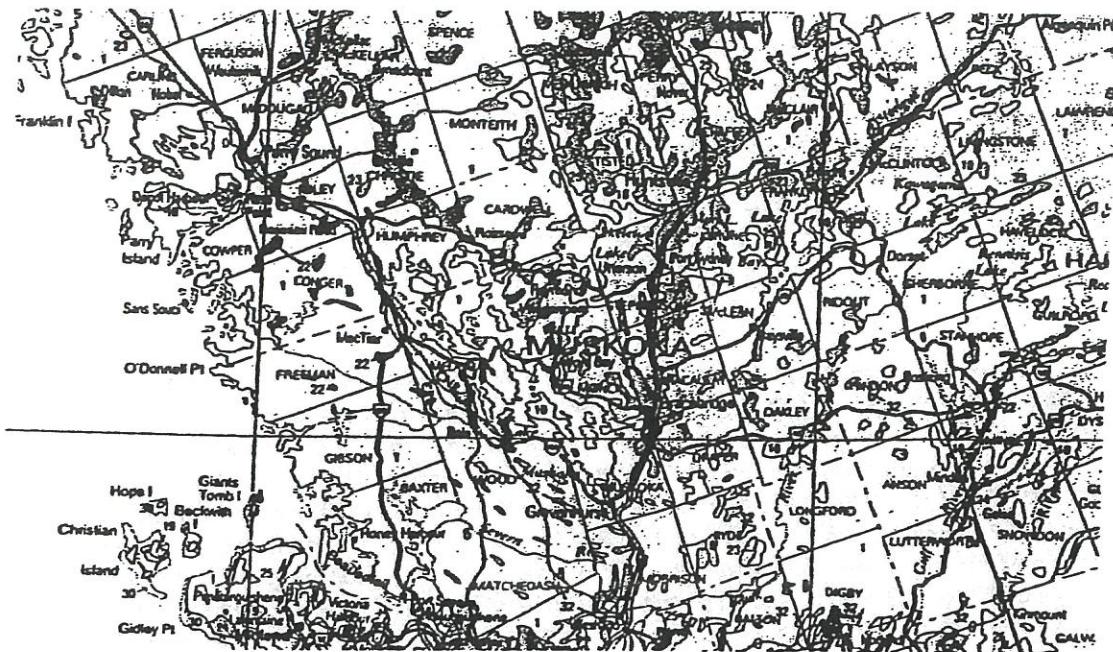
Figure II.17.5 Quaternary Geology of Muskoka, Ontario (from Barnett et al., 1991). Pink areas (1) denote igneous and metamorphic bedrock, which is exposed or covered with thin drift. Blue areas (24) are glaciolacustrine deposits of clay and silt. Remaining colors are glaciolacustrine deposits of outwash and till, sand and gravel (18, 23, 25) or organic peat and muck (32).

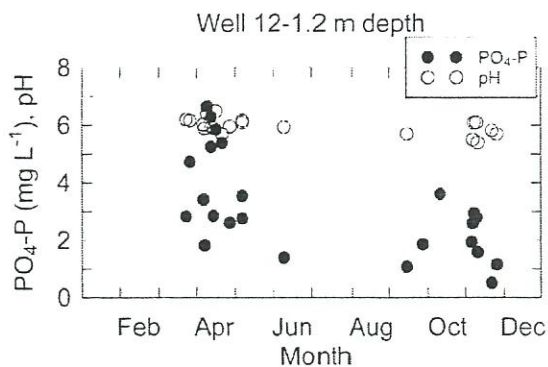
Fig. 4. Seasonal trends of PO₄-P and pH in well 12–1.2 m depth, during 6-yr period from 2006 to 2011. Values are from individual sampling events. Well is located below the down gradient edge of the tile lines.
