**Re: Poverty Bay Road Culvert Replacement**

As requested by the Township of Magnetawan, the Greer Galloway Group has completed an as-built survey of the Poverty Bay Road Culvert replacement project. This letter is in response to homeowners concerns regarding the culvert inverts, potential flow rates through the new culvert, and design parameters contained in the Canadian Highway Bridge Design Code (CHBDC).

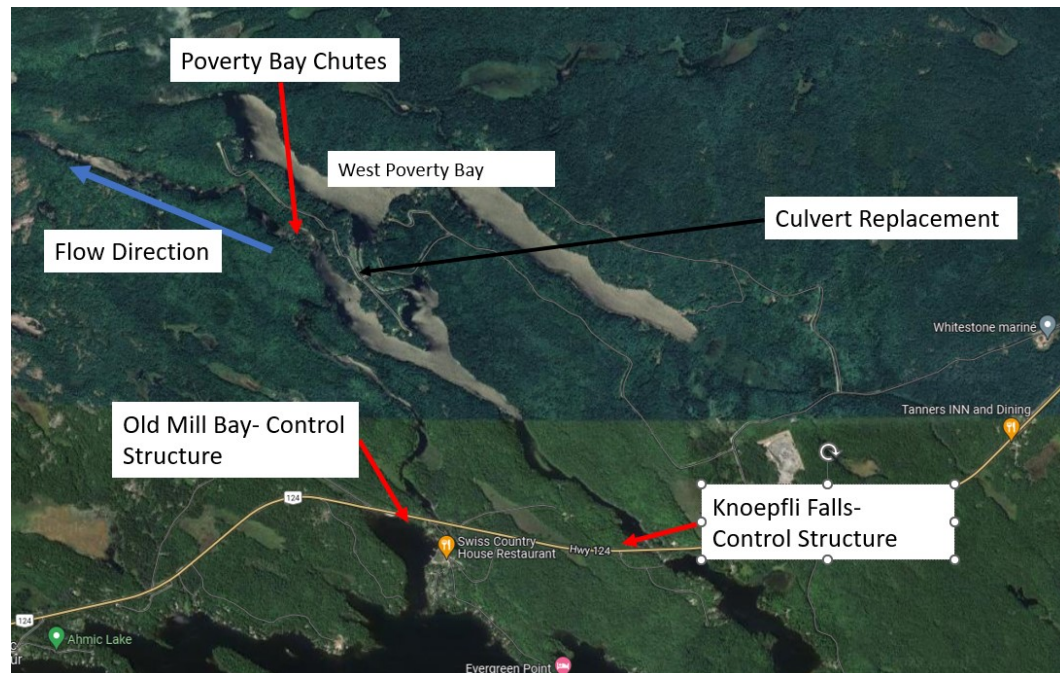
**Figure #1: Watershed system around West Poverty Bay**

West Poverty Bay acts as an equalization basin for the Magnetawan river system. The Magnetawan river is a controlled water system meaning the water levels within the system are regulated through the use of control structures. The two structures upstream of West Poverty Bay, located at Knoepfli Falls & Old Mill Bay, regulate the amount of water exiting Ahmic Lake and accordingly the amount of water entering the section of river encompassing West Poverty Bay.
