Structure Name:	Bay street bridge - Bridge #10		
Main Hwy. / Road #:	Bay Street	On <input checked="" type="checkbox"/> Under	Crossing Type: Navig. Water
Highway / Road Name:	Bay Street		
Structure Location:	0.5 km W of Highway 520		
Easting	17 605251	Northing	5057500
Owner(s):	Municipality of Magnetewan	Heritage Designation:	Not cons.
MTO Region:	Northeastern Region	Road Class:	200
MTO District:	Huntsville	Posted Speed:	80
		No. of Lanes:	2
Old County:		AADT:	105
		% Trucks:	
Geographic Twp.		Inspection Route Sequence:	
Structure Type:	Other - Undefined	Interchange Number:	
Total Deck Length:	6.9 m	Interchange Structure No.	
Overall Str. Width:	9.3 m	Min. Vertical Clearance:	m
Total Deck Area:	64.17 m ²	Special Routes:	N/A
Roadway Width:	7.3 m	Detour Length Around Bridge:	km
Skew Angle:	0 deg.	Direction of Structure:	E-W
No. of Spans: Span	1	Fill on Structure:	m
Lengths:	6.6 m

Field Inspection Information:			
Date of Inspection:		Type of Inspection:	OSIM
Inspector:	Kevin Hawley, P.Eng.		
Others in Party:			
Access Equipment Used:	Camera, Measuring Tape (3m), Boots, Hat, Gloves, Vest, Inspection Forms and Clip Boards		
Weather:	Sunny		
Temperature:	20 °C

BRIDGE PHOTOGRAPHS

Struct

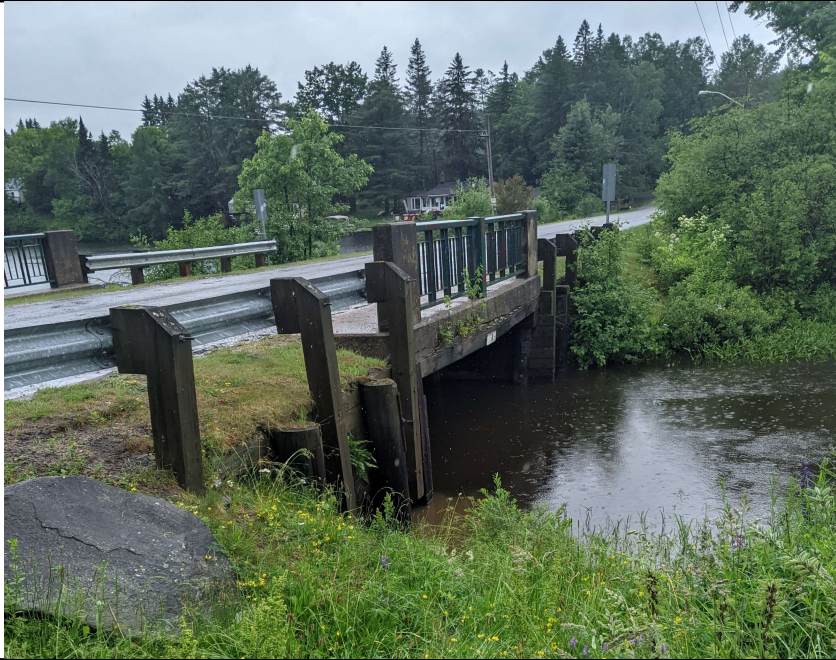
Photo 5: Elevation Shot

Repair and Rehabilitation Required:		Priority				Estimated Construction Cost
Element	Repair and Rehabilitation Required	6 to 10 years	1 to 5 years	Within 1 year	Urgent	
Bridge #10	Replacement				X	\$ 750,000.00
Bridge #10	Engineering Fees					\$ 75,000.00
Total Cost						\$ 825,000.00
